IMPROVED REFLECTOR ASSEMBLY

AN/VSS-3 SEARCHLIGHT  
(U)

FINAL TECHNICAL REPORT

PICHEL INDUSTRIES, INC.  
PASADENA, CALIFORNIA

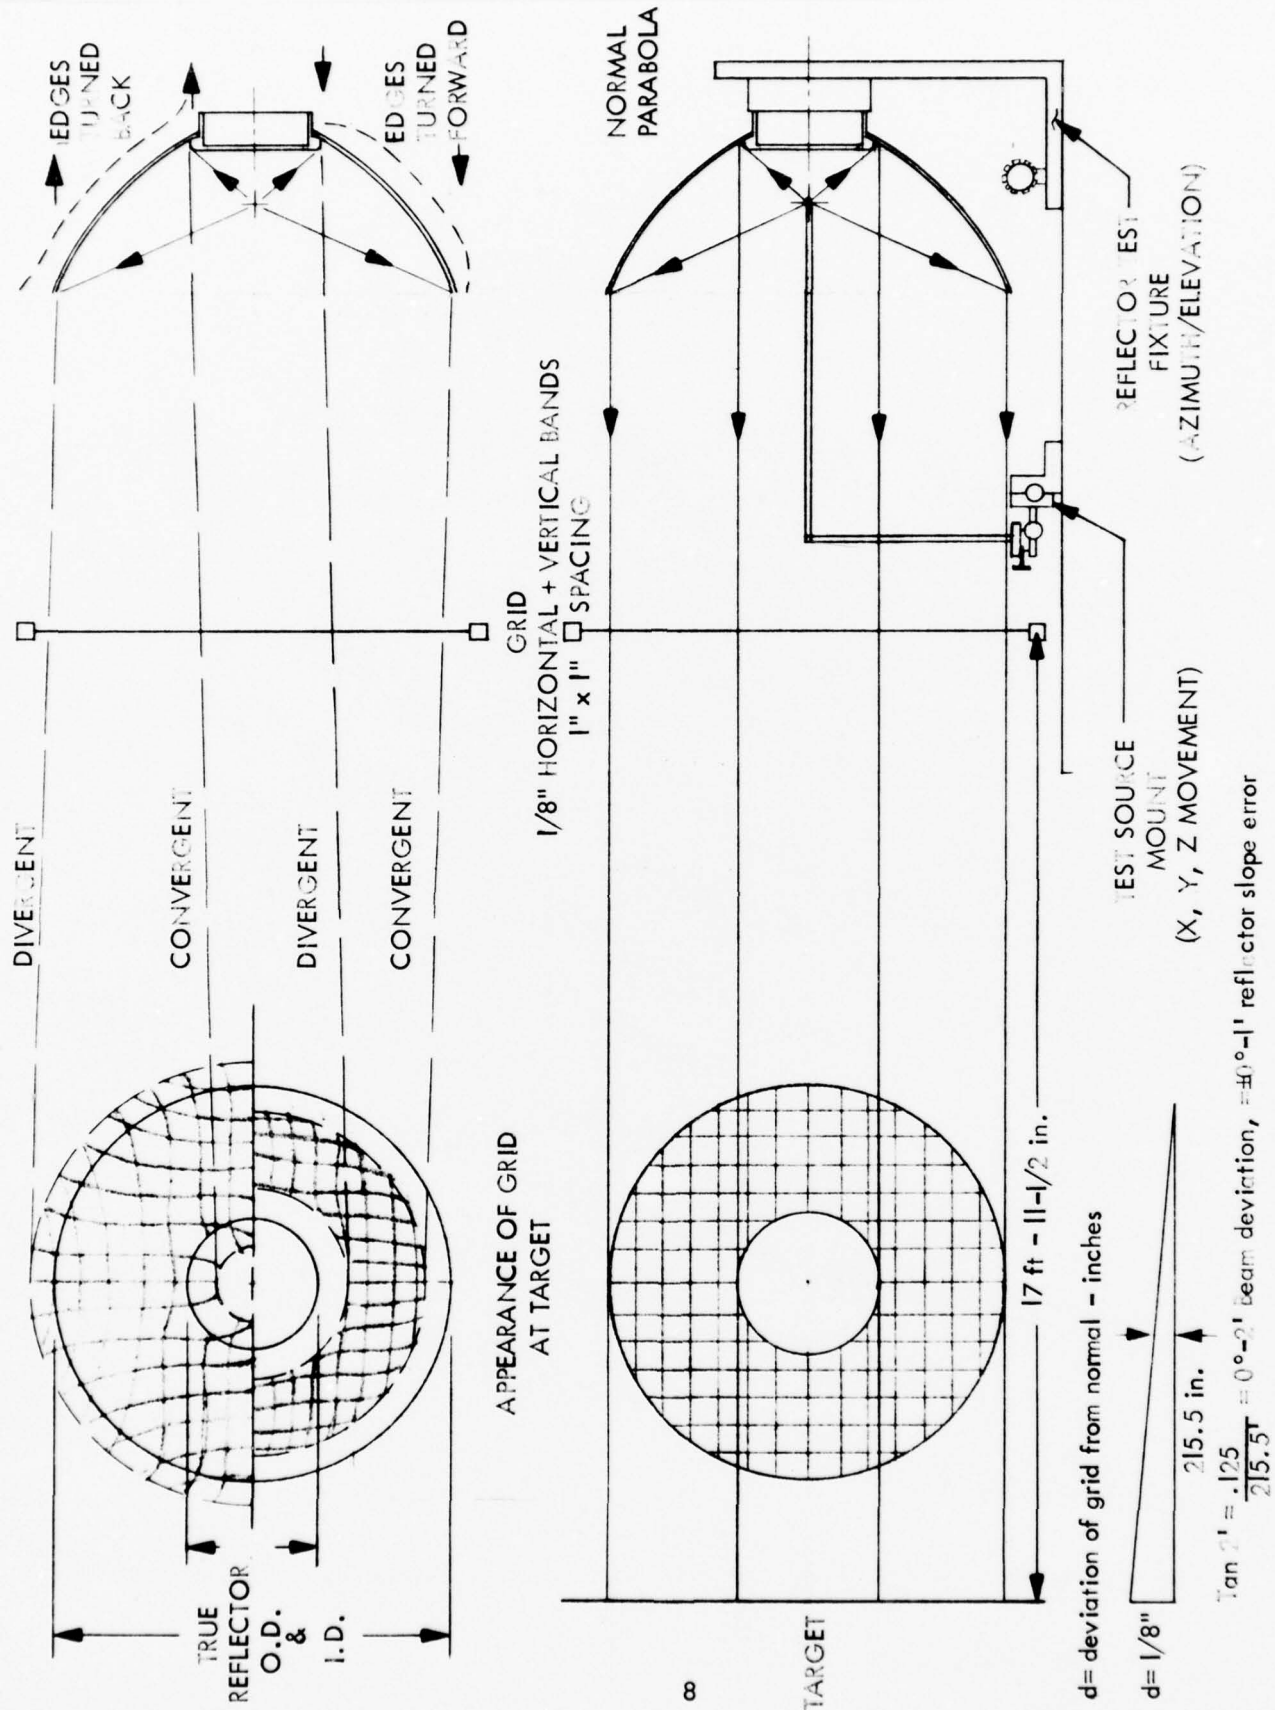
FIGURE 1

A. Grid Test - The Reflector assembly is positioned on a support structure which is capable of movement in both elevation and azimuth. A point light source is positioned on a manipulator which provides a capability of three axes adjustment (X-horizontal, Y-vertical, and Z-axial). A grid of 1/8 inch wide bands equally spaced at one inch intervals, both horizontally and vertically, is placed in front of the reflector so that the collimated light from the reflector is projected through the grid to a target area, where it is observed and/or photographed.

If local anomalies or deviations of the reflector shape exist, the deviations cause the shadow pattern of the grid to be displaced on the target, showing the exact location and extent of any anomaly.

The degree of angular deviation of the reflector can easily be calculated from the observed displacement of the grid pattern as related to the distance from grid to target. A diagram of the grid test components, and related calculations are shown in Figure 1.

GRID TEST DIAGRAM

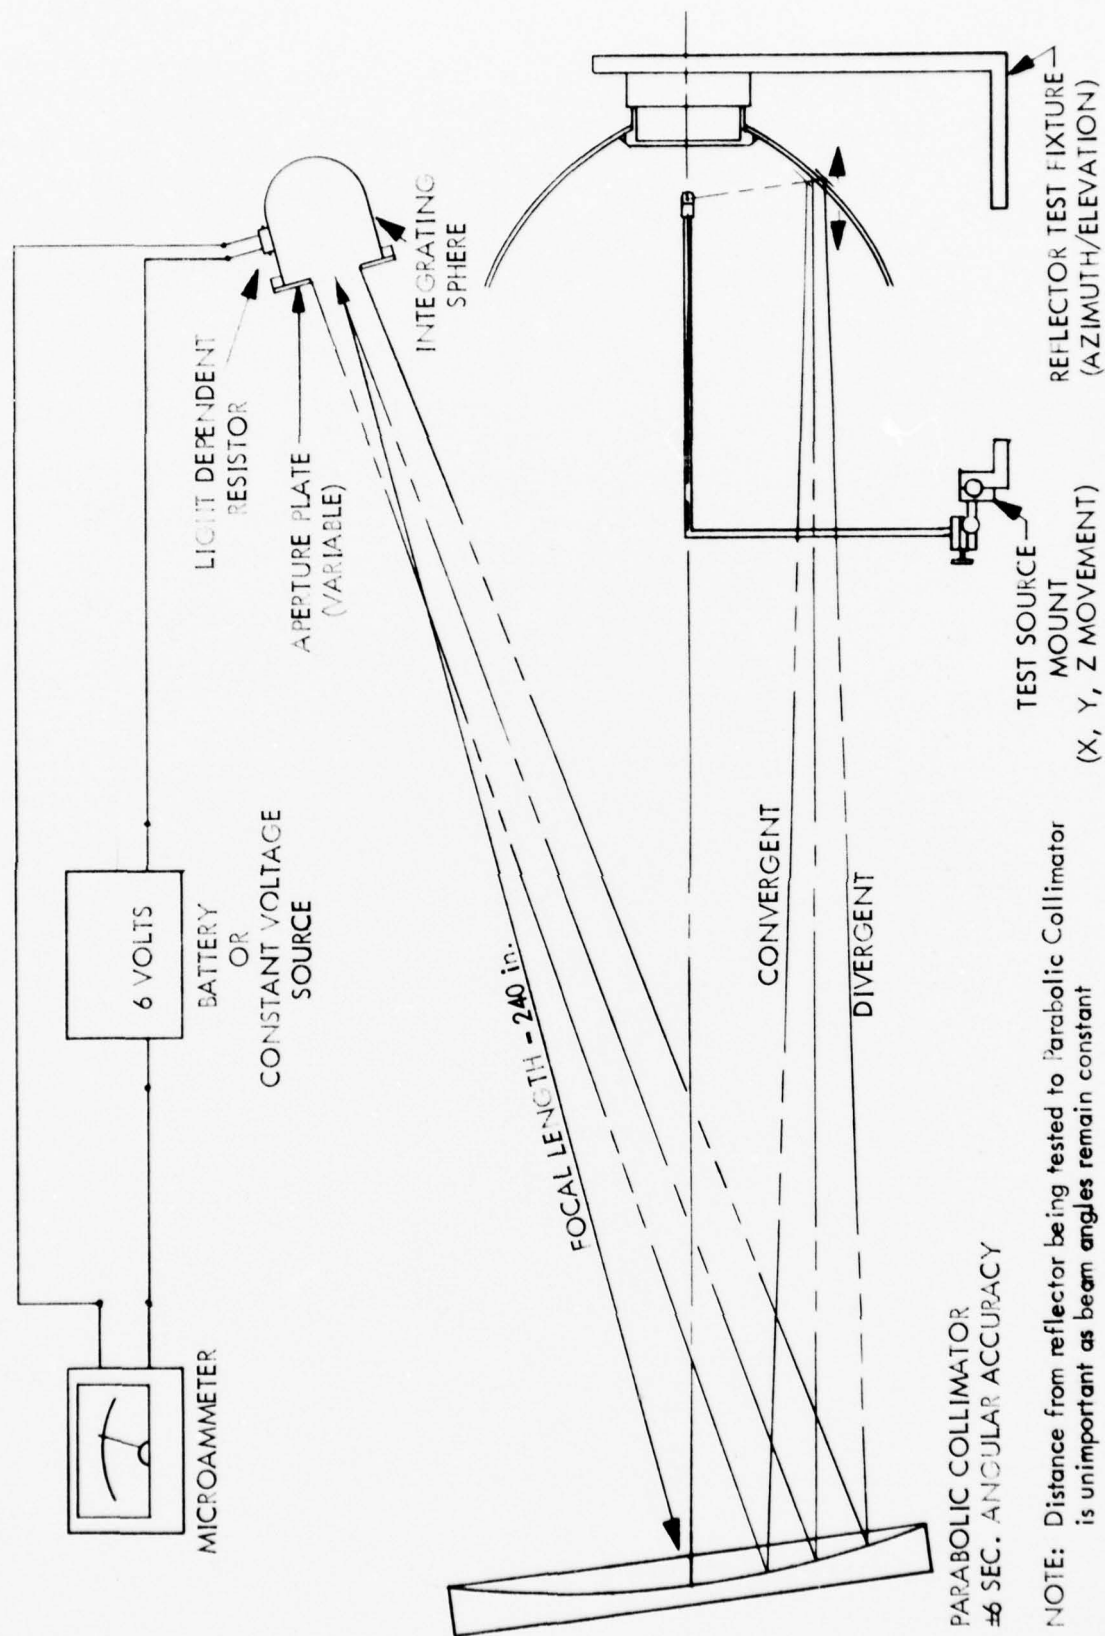
B. Sphere of Confusion Test - The standard sphere of confusion test is used to determine the overall integrated, or average, performance of a reflector assembly. In this test, the reflector and light source are positioned and utilized in a manner identical to that employed for the grid test, except that the grid is removed from the beam and instead of allowing the projected image to fall on a target for visual observation, the target is swung out of the way and the beam is directed onto the reflective face of a parabolic "collimating" mirror of high accuracy from which the rays are redirected to the focal point of the collimating mirror. An integrating sphere, having variable aperture plates, is positioned with the aperture at the theoretical focal point of the collimating mirror. Aperture plates having a variety of different entrance aperture diameters, which by calculation relate to various "spheres of confusion", allow determination of the overall accuracy of the reflector

FIGURE 2  
SPHERE OF CONFUSION TEST DIAGRAM

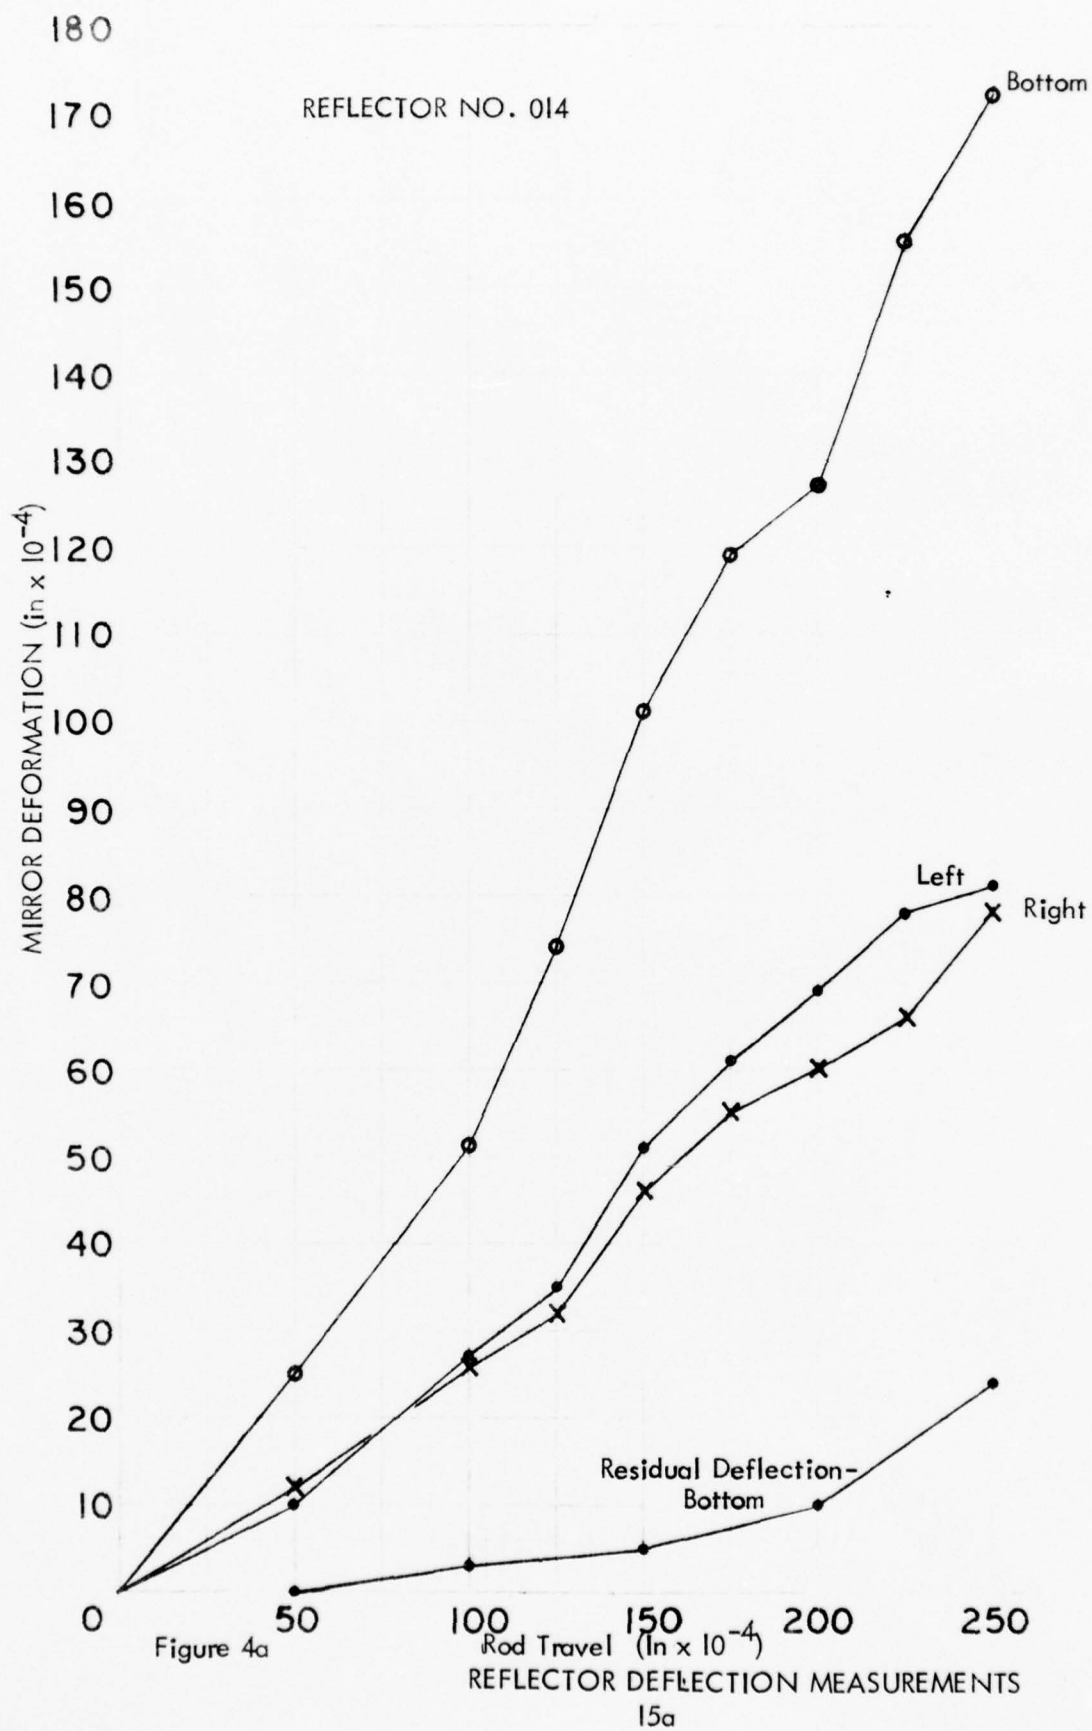
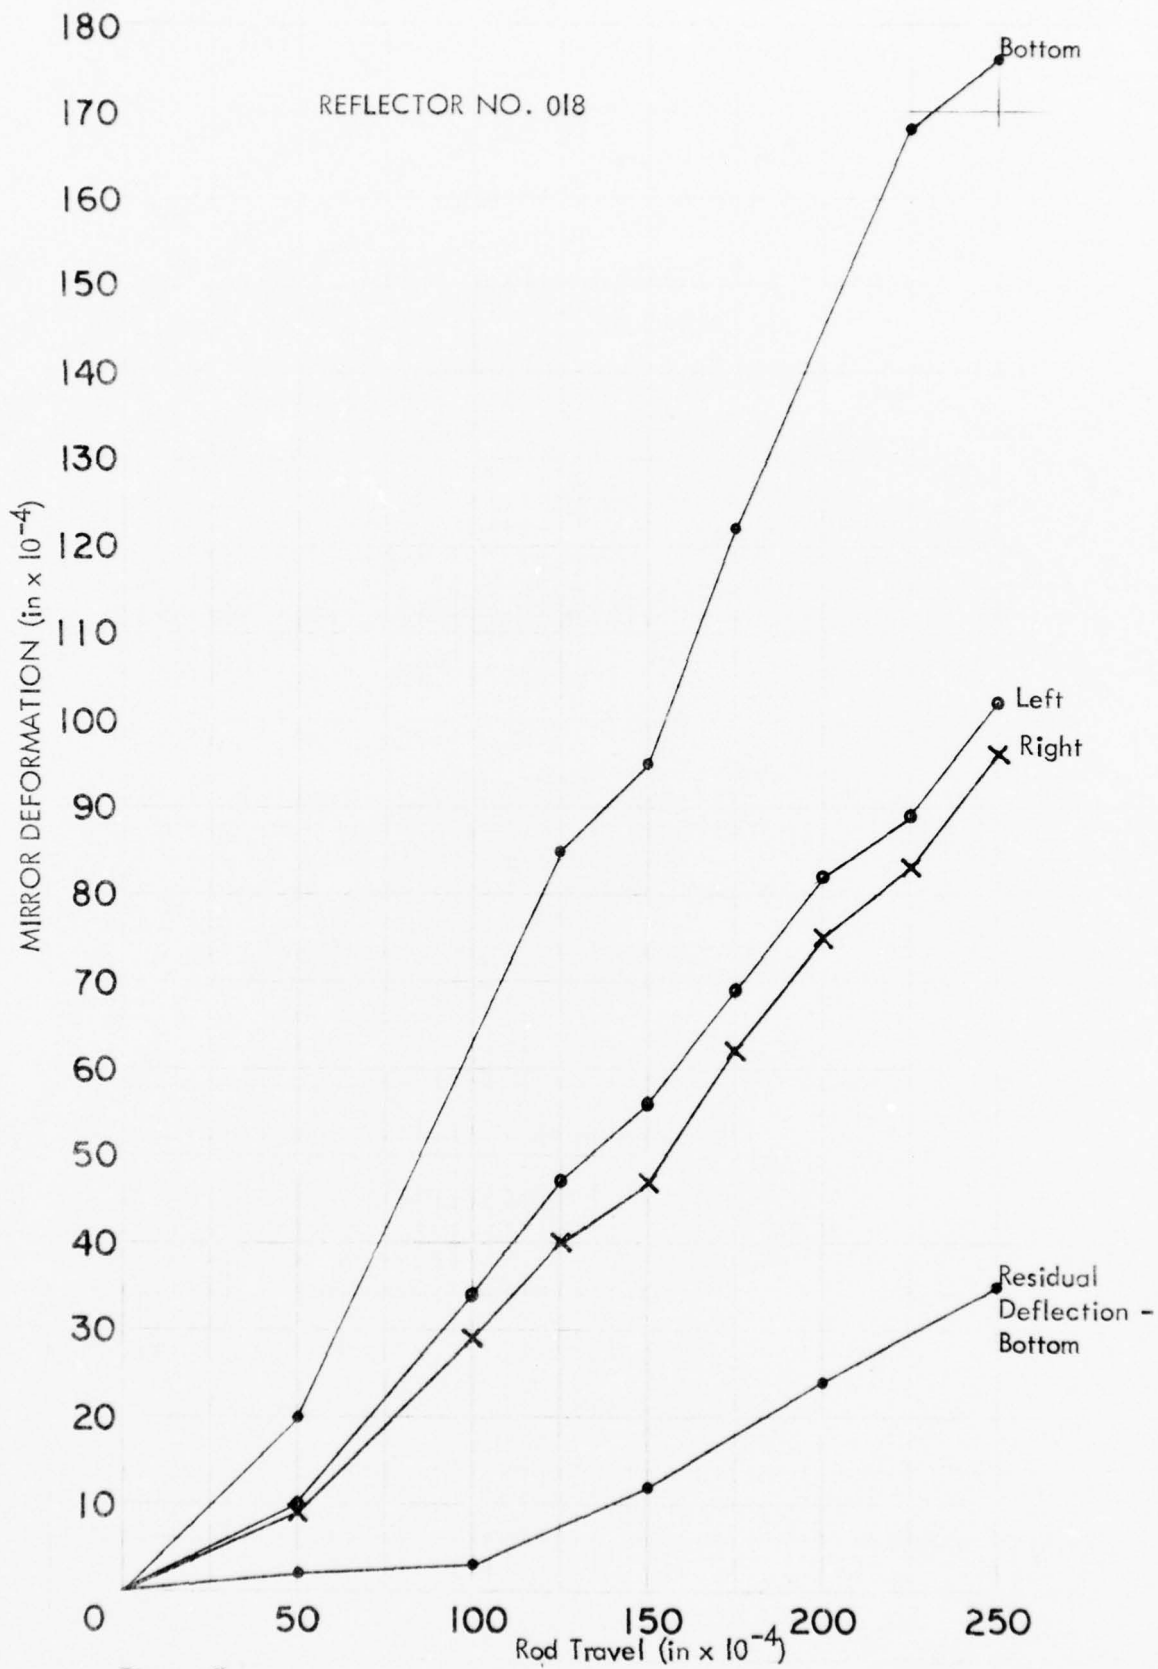
Figure 4b

Since it has been stated by the technical personnel involved with searchlight assembly and test that the push mechanism is normally adjusted to provide a stroke of only approximately .200", and since the maximum possible deflection induced by the drive mechanism is .270", the test parameters which provided deflection movements up to .500" actually applied deflective forces more than double those which would be experienced in actual operation. Graphs showing the results of these deflection tests are shown in Figure 4.

REFLECTOR DEFLECTION MEASUREMENTS

It should be noted that while certain of the original SC-D-647010 Reflector Assemblies showed little residual distortion at normal deflection levels, other units exhibited

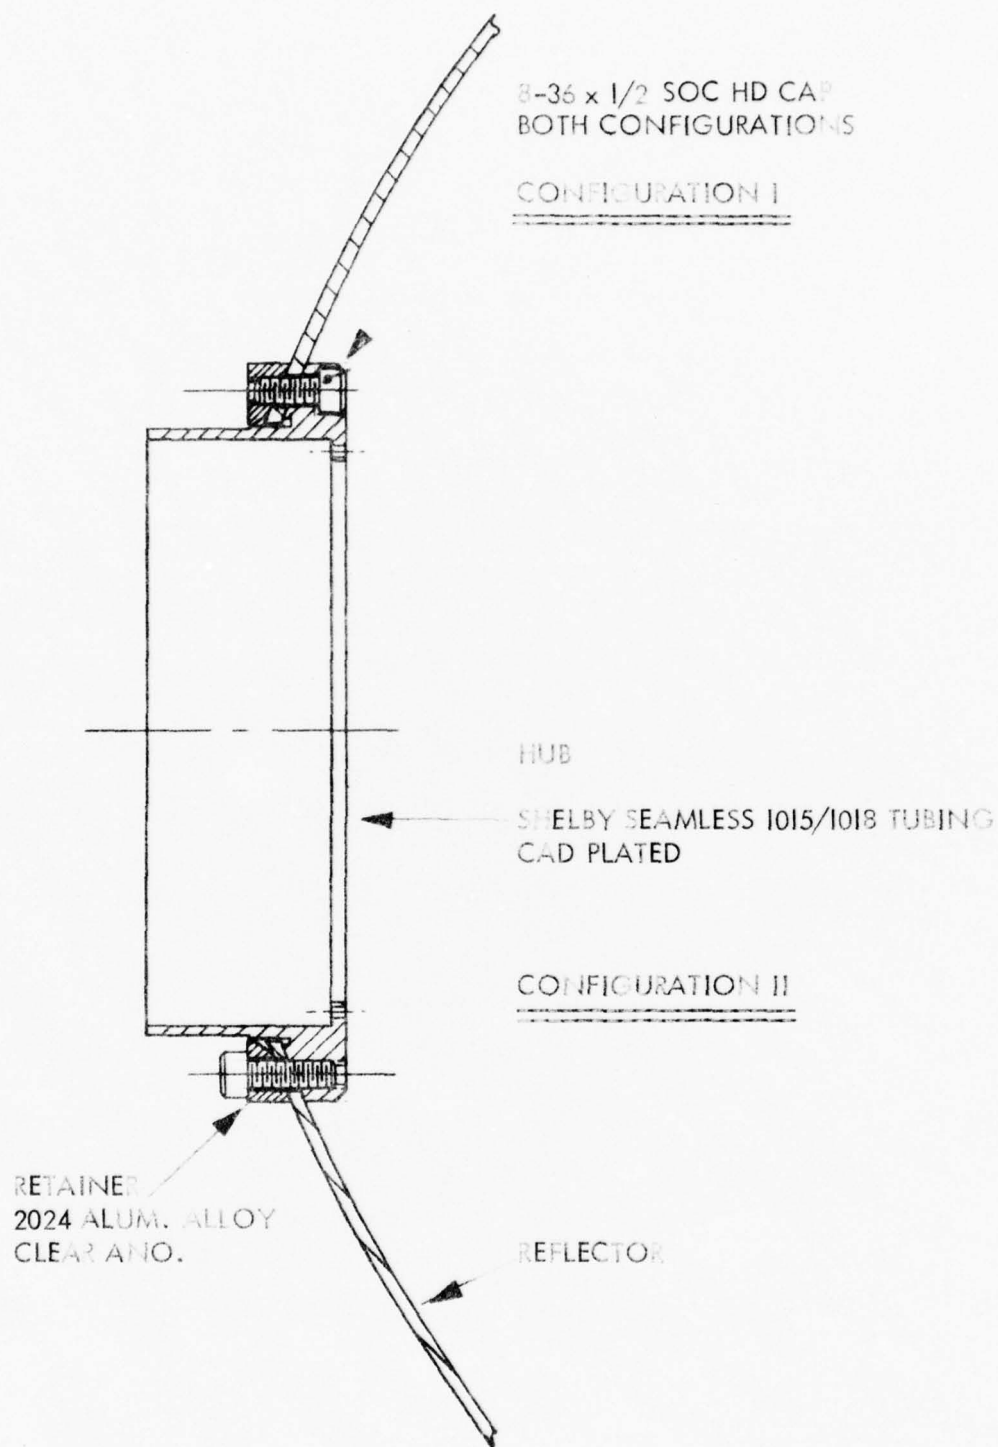
FIGURE 5 INITIAL REFLECTOR ASSEMBLY RE-DESIGN I

Both configurations of the new hub were detailed and initially fabricated, but, through discussions with the COTR it was decided to pursue Configuration 2, due to the apparent advantages listed above.

Since the reflector assembly is purchased and utilized as a "complete assembly" it seems more reasonable that the dimension of real criticality is the actual distance from the point of attachment to the Searchlight to the "best" focus of the parabolic reflector. Where even relatively gross ( $\pm .050$  inches for instance) deviations of reflector focal length, if properly positioned relative to the arc source, would produce immeasurable differences in performance, it has been proven that minor deviations (on the order of  $\pm .010$  inches) in the relative position of arc "hot spot" to reflector "best focus" can produce marked changes in peak beam candlepower, beam holeing characteristics and total beam angle.

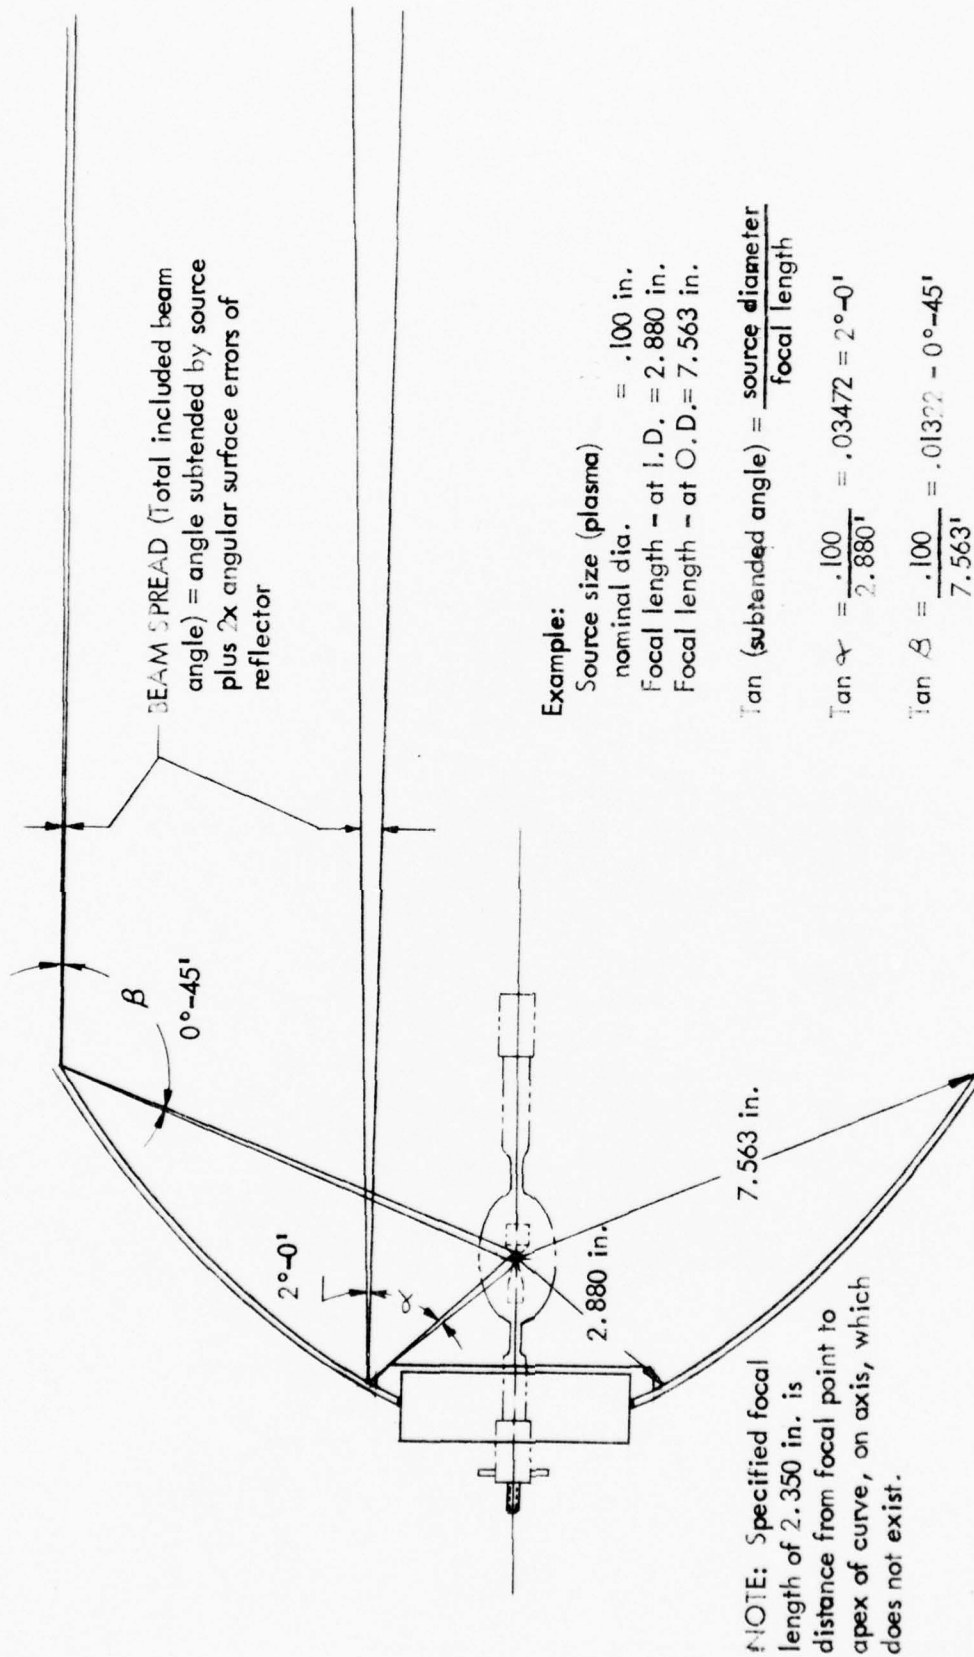
The relatively deep, low f number reflector configuration utilized in the AN/VSS-3 Searchlight, although specified to have a focal length of 2.350", in fact, combines a multiplicity of actual focal lengths. Figure 6 illustrates the typical variations in focal lengths which occur.

Since the effective radiation source, or plasma ball, of the xenon short arc lamp is reasonably symmetrical and therefore exhibits the same general, overall dimensions when viewed from different angles, the actual beam spread varies as a result of reflection from different portions of the reflector, due to the varying focal lengths. Because of this variation, angular deviations, or anomalies, of the reflector near the rim, where focal lengths are longer, produce a different effect on performance than do similar deviations or anomalies near the center of the reflector.

FIGURE 6 FOCAL LENGTH AND BEAM ANGLE VARIATIONS

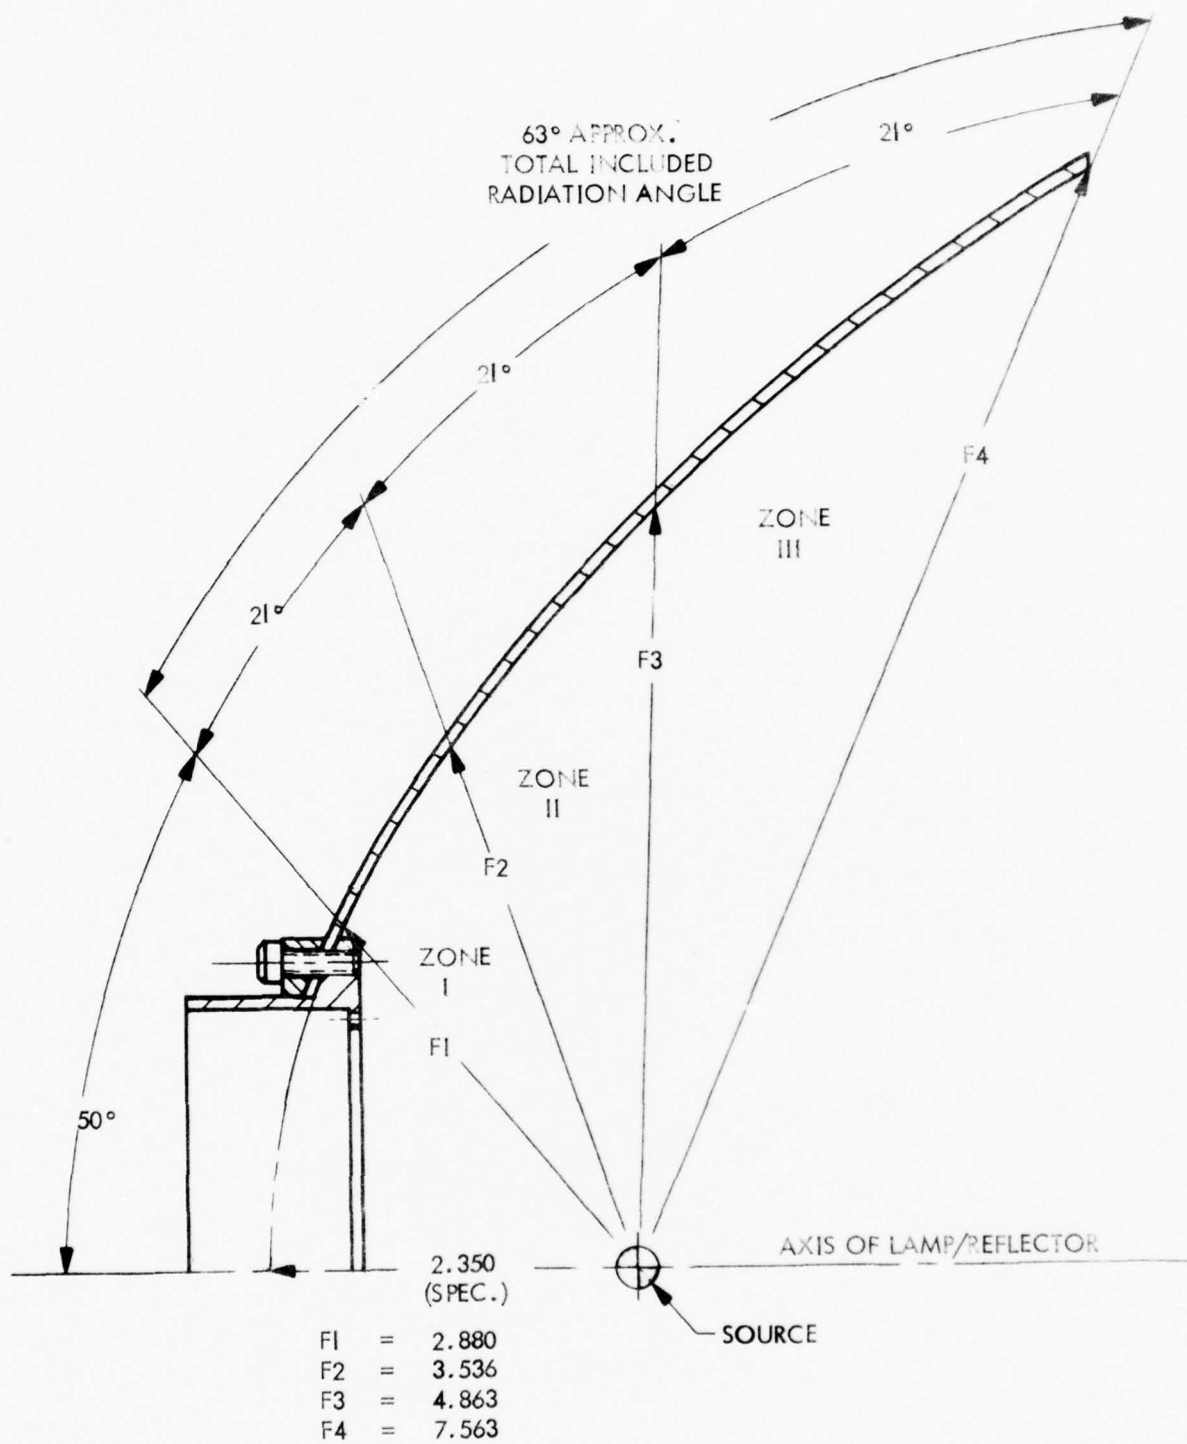
FIGURE 7

To enable a more specific evaluation of the effect of the variable focal distances on circle of confusion test results, the reflector surface was arbitrarily divided into three zones. These zones were defined by dividing the total effective radiation angle of the source (as defined by the total solid angle subtended by the source between the rim and hub of the reflector) into three equal segments. Although the polar energy distribution of the xenon short arc lamp is not completely uniform, this division was arbitrarily chosen as a reasonably effective way of dividing the total beam energy into three zones, rather than by other techniques such as division of the reflector surface area, etc. Figure 7 illustrates this division of energy and the resultant projected sections of the reflector which relate to each zone.

A masking technique was evolved, whereby each of the zones could be masked individually, or in conjunction with other zones, to allow the characteristics of each individual zone to be independently evaluated relative to the sphere of confusion test. As was expected, angular deviations occurring in any of the three zones produced the same general degree of beam deviation at the aperture of the integrating sphere, but the accuracy of measurement of the effect of such deviations or anomalies was progressively masked as the zonal tests progressed from rim to

DIVISION OF REFLECTOR INTO 3 ZONES

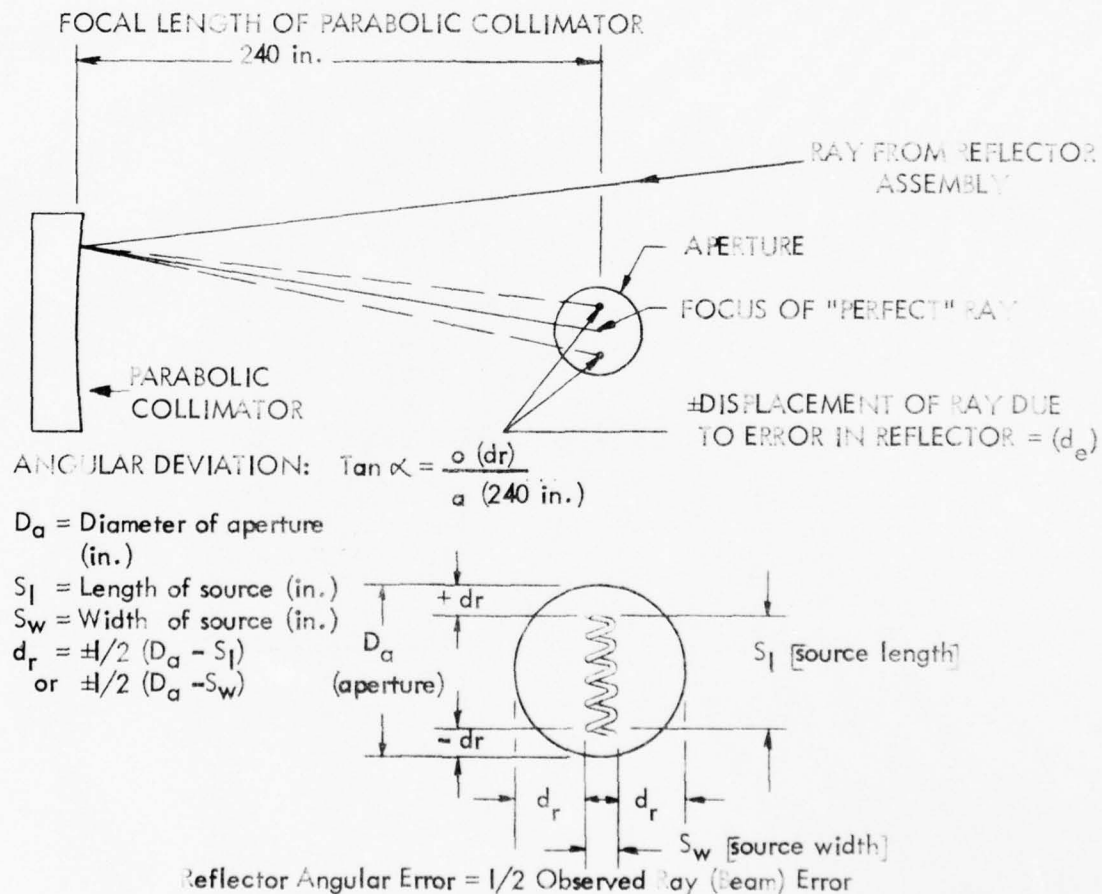
FIGURE 8 SOURCE MAGNIFICATION VS. REFLECTOR ERRORS

magnification of the test source, as reproduced at the plane of the test aperture, for the various focal lengths actually occurring at the beginning and end of each of the three zones.

Figure 8 also lists the reflector angular errors which, when combined with the magnified source size resulting from the various focal lengths listed, could result from the use of a test aperture of 4.085 in. diameter. It can be seen that, for these conditions, allowable reflector errors run from  $\pm 3-3/4$  minutes to  $\pm 13-1/4$  minutes of angular slope error.

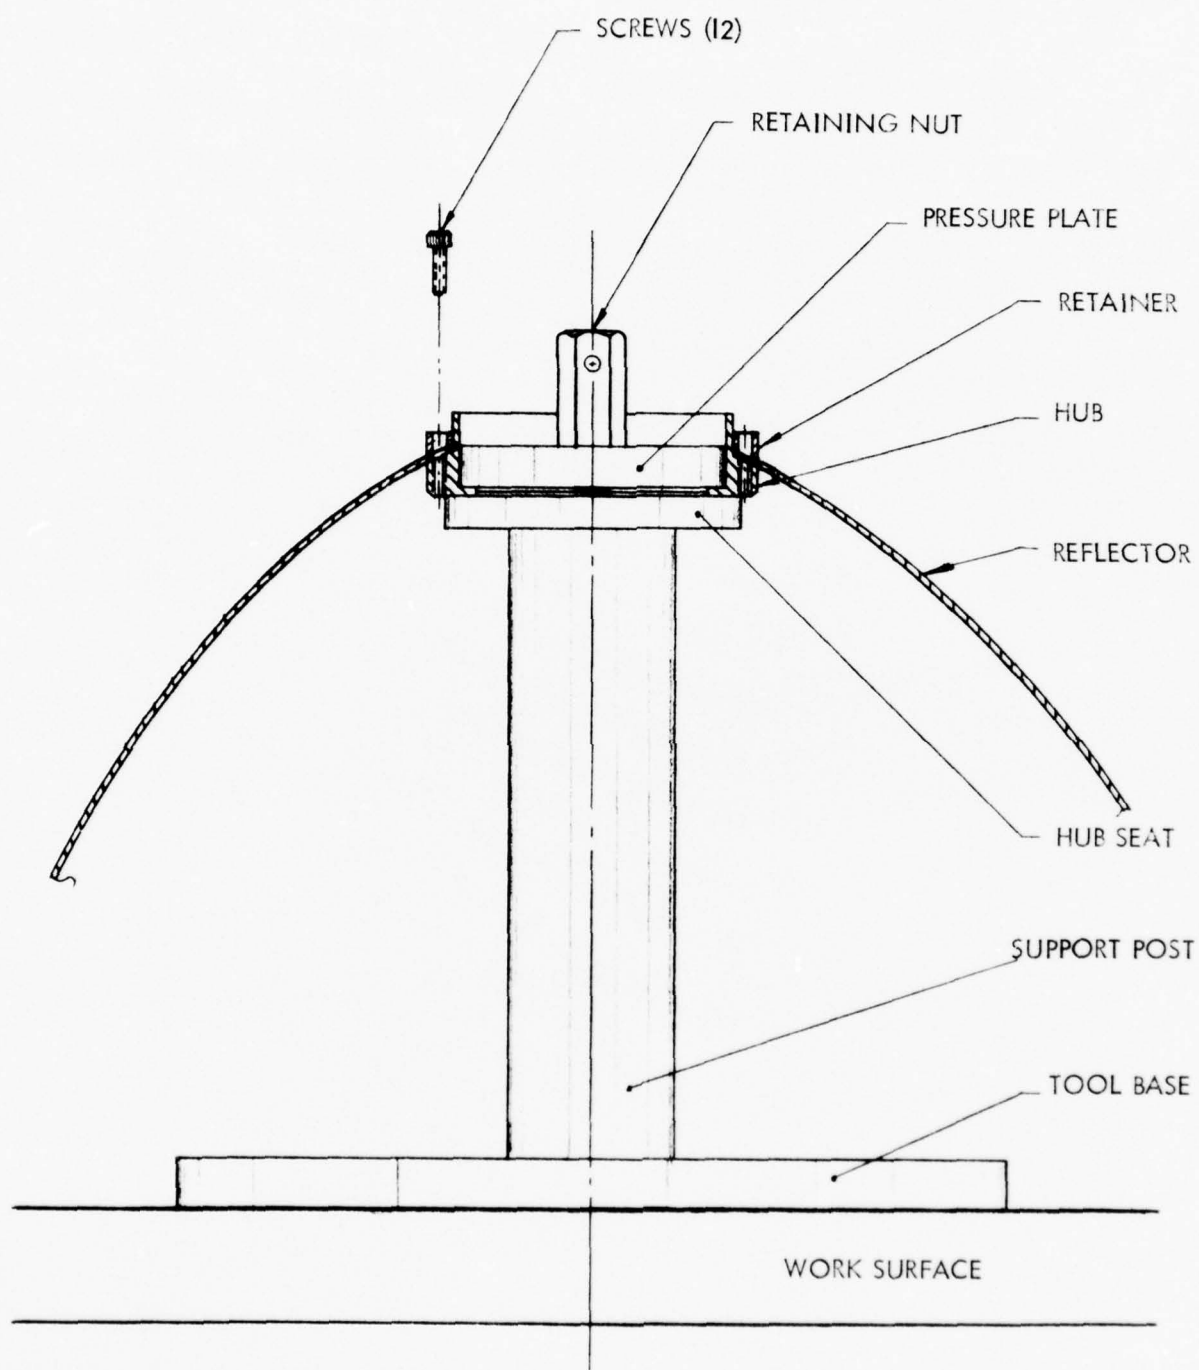
FIGURE 9

ASSEMBLY TOOLING

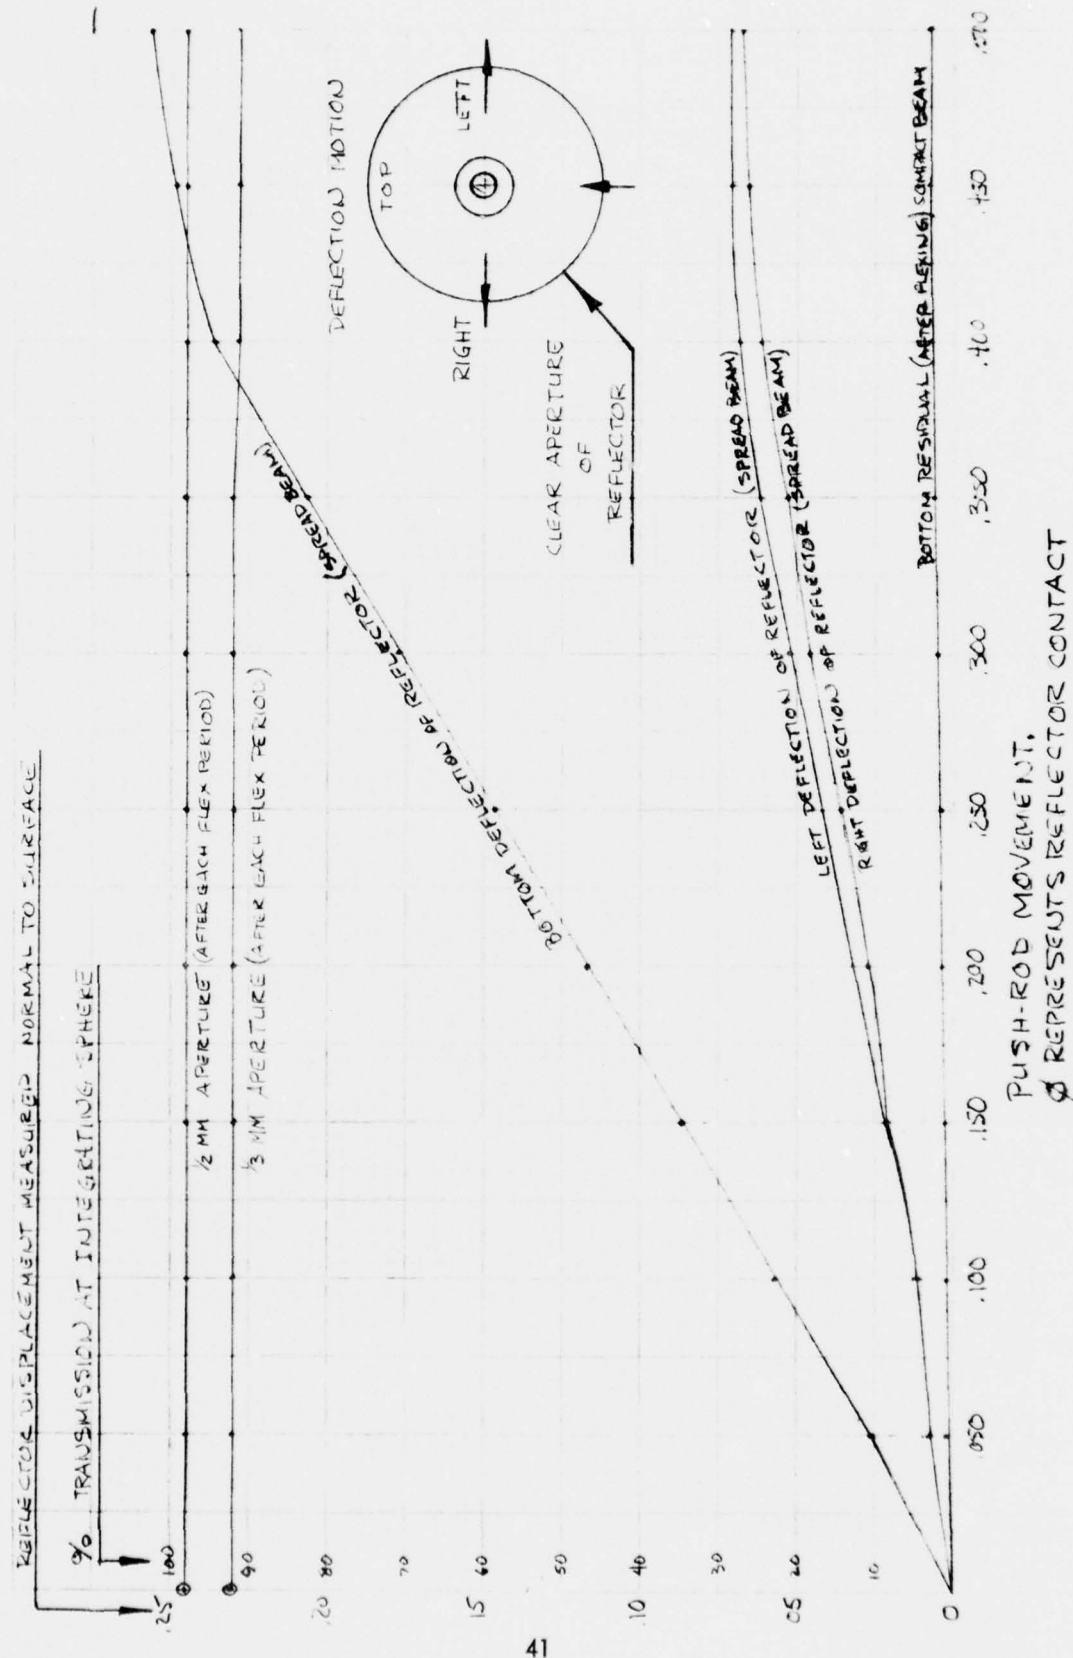
Final qualification tests included the new static grid and circle of confusion tests, followed by 100% over-flexing in the modified searchlight/test fixture as well as multiple flexings in the searchlight at operational temperatures. Figure 10 shows the varying degrees of deflection which the re-designed units were subjected to, the minimal residual deflection and the virtually nonexistent performance degradation that resulted.

FIGURE 10 DEFLECTION VS PERFORMANCE, RE-DESIGNED REFLECTOR ASS'Y

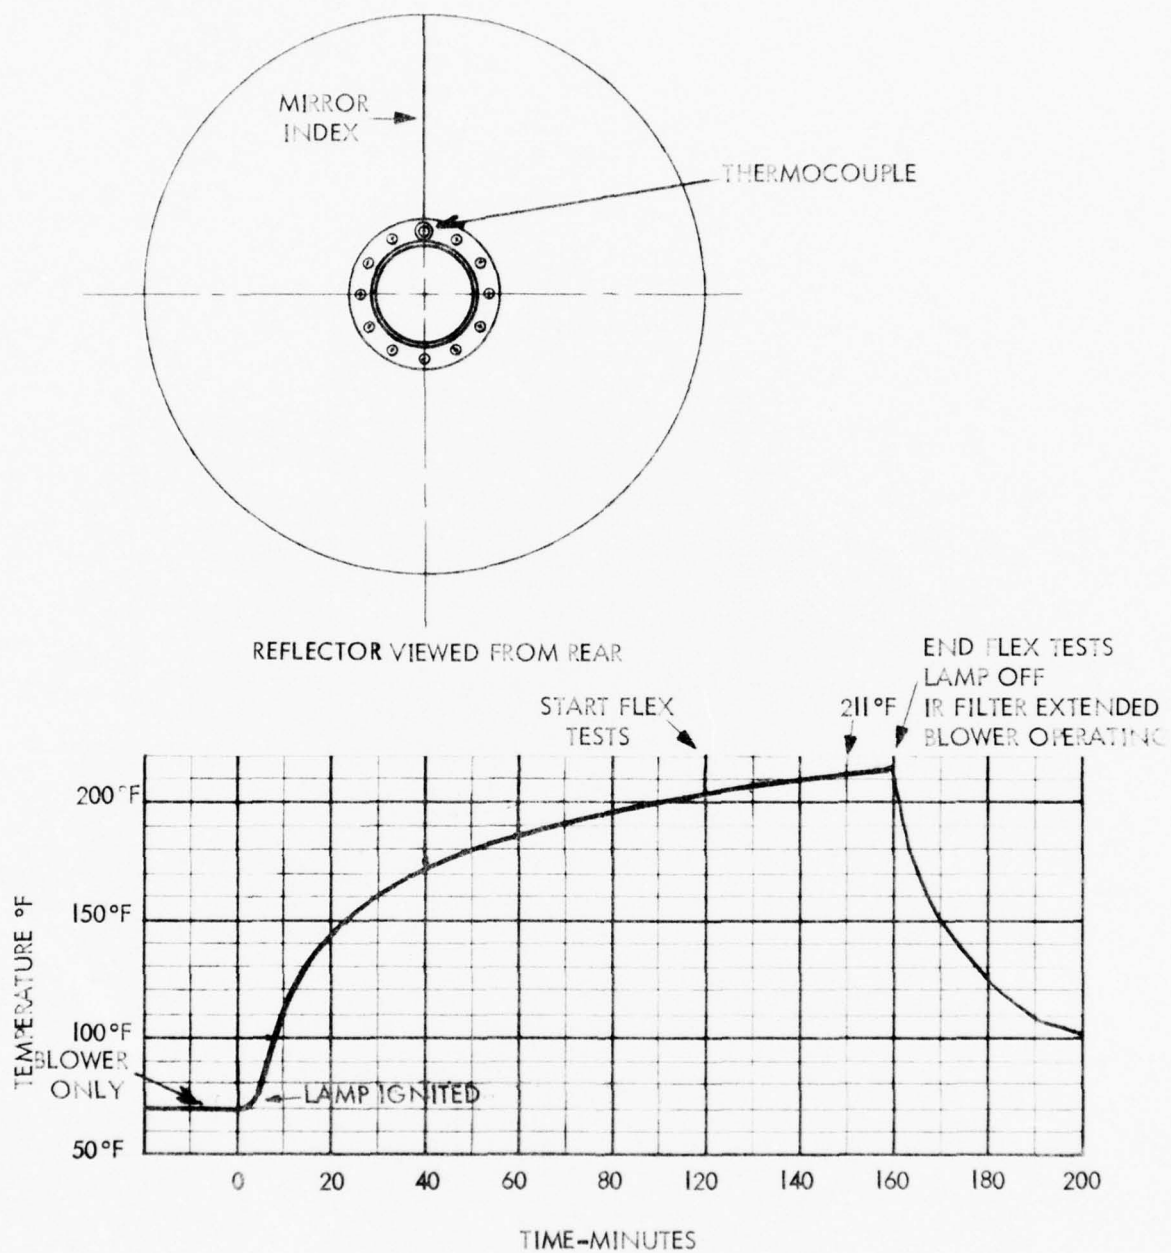
FIGURE 11 REFLECTOR/RETAINER TEMPERATURE

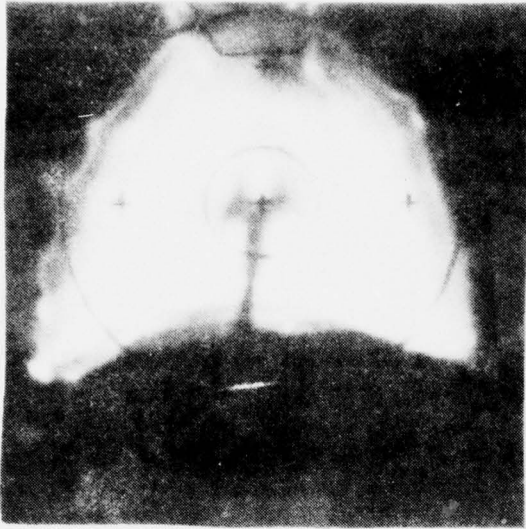
The deformed mirror was returned to PII where the degradation was immediately confirmed by application of projected grid and sphere of confusion tests. A photograph of the projected grid test of this reflector (serial number 37-49) as returned from Varo, is shown in Figure 14 a, which clearly shows the severe deformation which existed. Repeated tests at Varo with other new reflector assemblies produced similar results.

a. Reflector Assembly #37-99 As Returned From Varo, Inc.

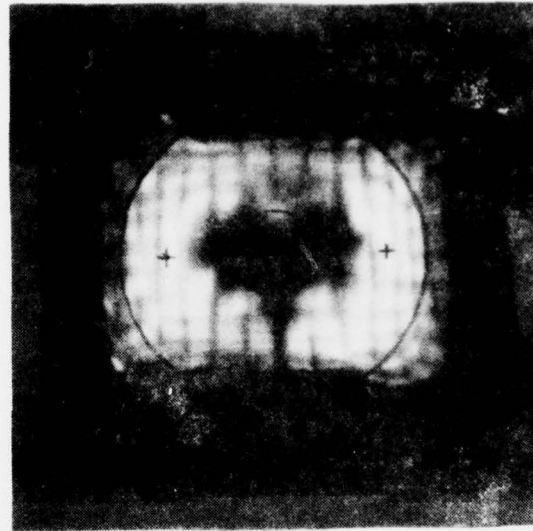
b. Reflector Assembly #37-99

The projected grid photograph, Figure 14 b, shows reflector number 37-99 after undergoing a deflection duration of two-and-one-half hours. Flattening at the bottom of the picture is that which was induced by the prolonged high temperature deflection at PII. The flattening at the top of the picture is that which was previously induced by operation under the test conditions imposed at Varo, Inc. It can be seen that the type and extent of degradation is nearly identical.

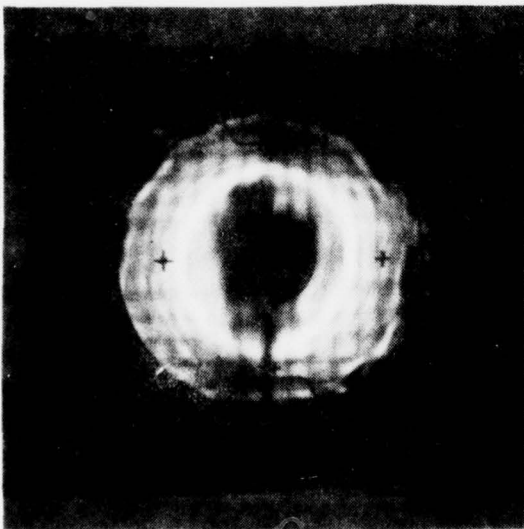
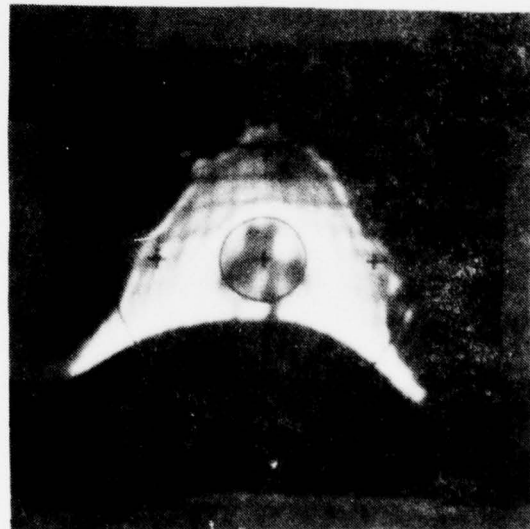
FIGURE 14

c. "Old Style" Reflector Assembly #43-165 Prior to "High Temperature", Prolonged Deflection Test

d. "Old Style" Reflector Assembly #43-165 After "High Temperature" Prolonged Deflection Test.

more than two years previously were re-tested under the new conditions. The "old style" reflectors exhibited exactly the same characteristics, taking on a pronounced deformation in the area where the deflective forces were applied. Figures 14 c and d show a projected grid test of one of the old style reflector assemblies, number 43-165, both before and after the high temperature - prolonged deflection tests.
